SCHEDULE OF WORKS

1.8 Traditional Repair and Conservation-Based Approach

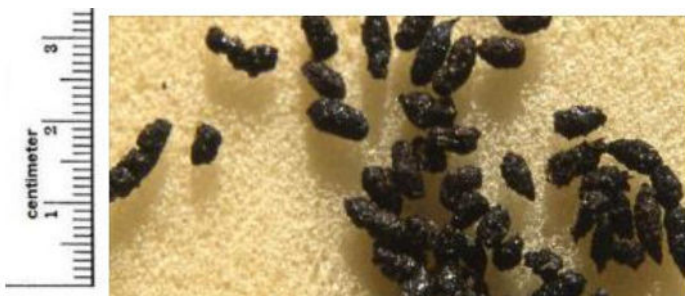
Photograph of bat droppings (with drawn scale). Bat species feed on insects and their droppings would therefore crumble to dust after a light amount of pressure is applied.

1.59 Inspection - Any deep masonry gap with the dimensions of 15mm by 40mm should first be inspected by torch light so as to confirm if bats are roosting in-side the gap and cavity of the wall. Bats are well-known for using such gaps. In the event that evidence of bat activity (bat droppings, scratch marks, fur, and urine staining) is observed within or around such a gap, then the gap should be left untouched and further advice be sought.
